# **White Paper Report**

Grant No. PF-50034-10

Planning for a Sustainable Preservation Environment for Collections

Grantee Institution: Abbe Museum

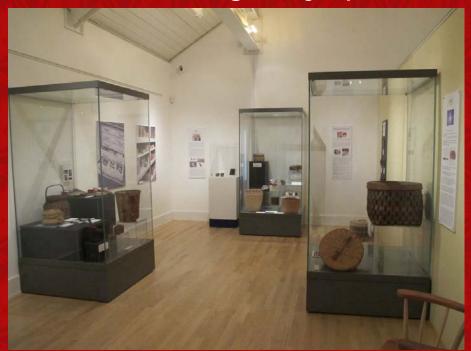
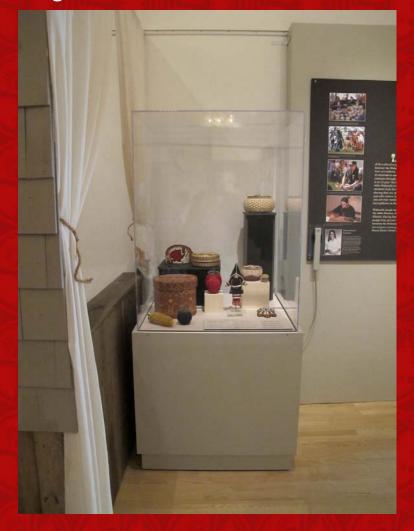
Use exhibit cases to buffer for temperature and RH fluctuations, possibly allowing for loosening of controls for the gallery space

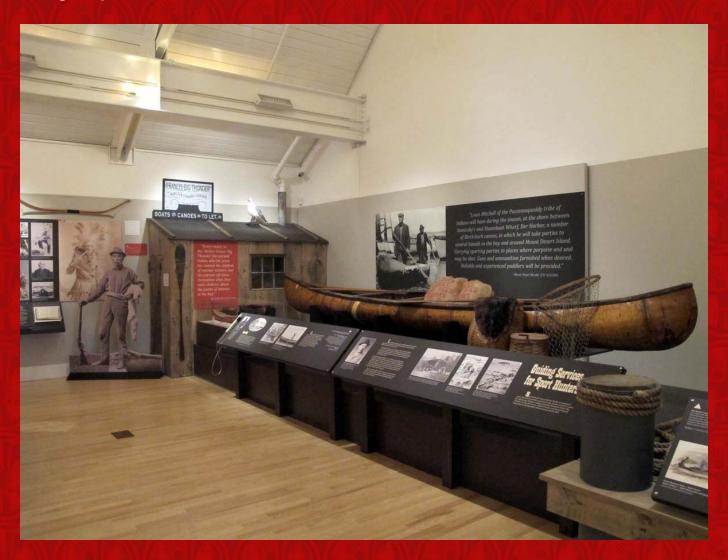
Use exhibit cases to buffer for temperature and RH fluctuations, possibly allowing for loosening of controls for the gallery space

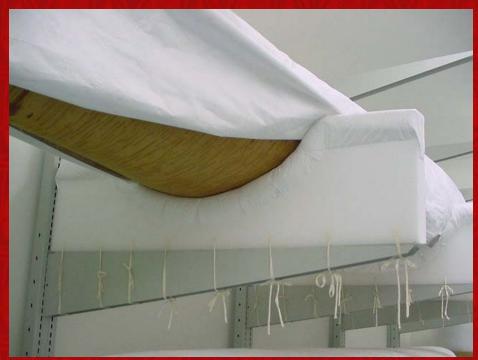
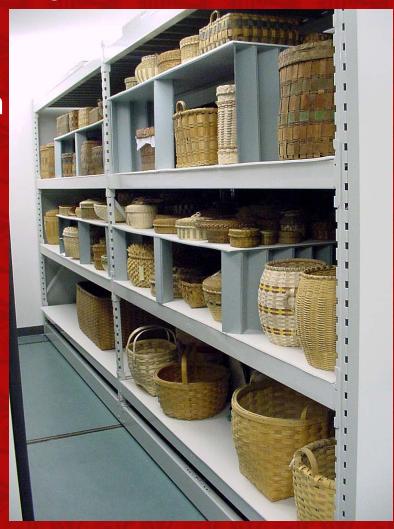
Use storage materials to buffer for temperature and RH fluctuations in storage to accommodate changes in gallery space (same HVAC zone)

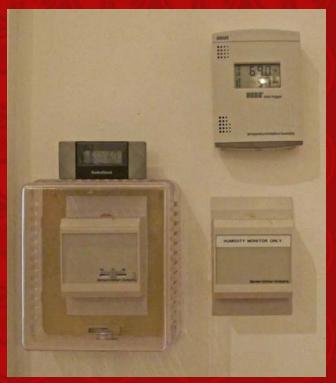
## HVAC System Improvements for Improved Efficiency and Reduced Energy Consumption (Electricity and Fuel Oil)

Improve accuracy, transparency and human interface of HVAC controls system

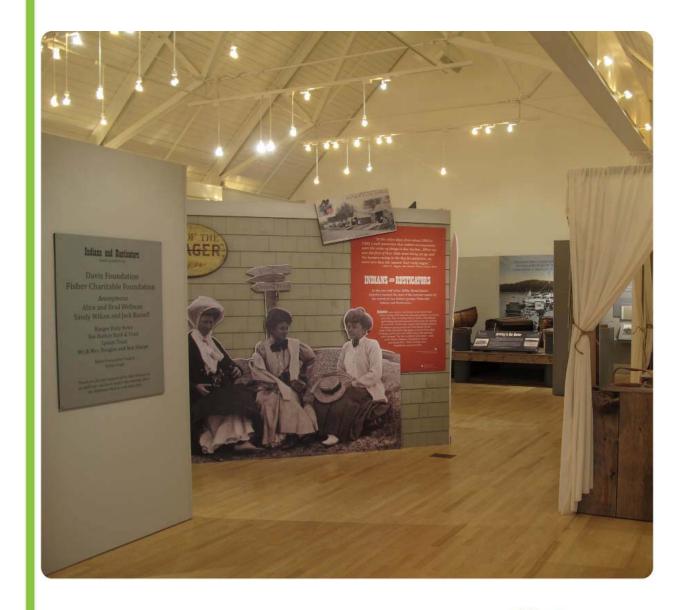
Replace halogen lamps in gallery lighting with LEDs, reducing cost and carbon footprint.

- Replace incandescent lamps with fluorescent lamps throughout building
- In exhibit galleries, replace incandescent track fixtures with (1) lower wattage fixtures and eventually (2) LED fixtures (gradually as technology improves and becomes more affordable)
- Reduce electricity use and demand through in-house awareness campaign and use of task lighting
- Overall redesign of gallery lighting system to improve energy use
